ASSESSMENT OF PRAYER ROOM FACILITIES IN KLANG VALLEY SHOPPING CENTERS THROUGH POST-OCCUPANCY EVALUATION

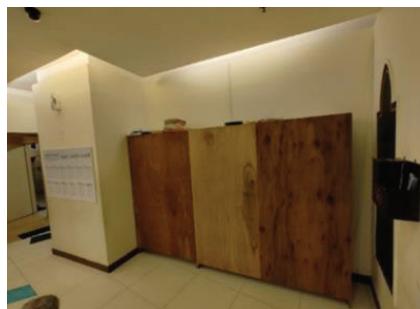
The evaluation of ablution facilities showed high ratings across shopping centers, except for SC 4, which scored the lowest due to the absence of non-slip measures on ceramic tiles, increasing accident risks on wet floors. SC 4 also received the lowest scores for prayer area maintenance, storage space, seating, shoe rack capacity, and availability of prayer essentials like *telekung* and mats. Backward-positioned cupboards (Figure 1) reduce usability,

Figure 1: Cupboard Placed Backwards in SC 4

Additionally, prayer rooms must be equipped with essential amenities, including shoe racks, storage spaces, prayer mats, and *telekung*, with regular maintenance and replacements

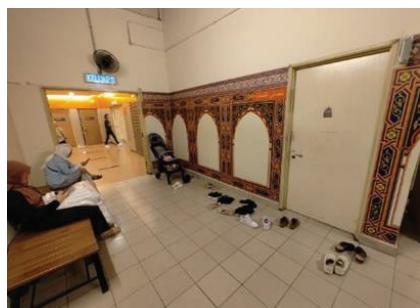
insufficient shoe rack capacity causes clutter (Figure 2), and a lack of prayer essentials inconveniences users. These findings highlight the need for targeted improvements to enhance functionality and user satisfaction [8, 9, 11].

Figure 2: Entrance of Female Prayer Room in SC 4

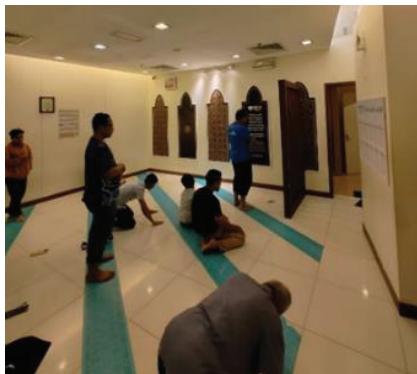
SC 4 scored lowest for design and layout, with the qibla direction facing the entrance (Figure 3), causing disruptions and congestion, particularly during peak prayer times, as individuals entering after ablution face those already praying. Additionally, SC 4 used floor tile alignment for qibla markers instead of prominent signage, which presented mixed user reactions (Figure 3). These issues emphasize the need for design improvements to enhance usability and comfort.

Figure 3: Layout of Male Prayer Room in SC 4

While some respondents appreciated the tile alignment, others preferred the clarity of

The placement of ablution facilities was rated positively across shopping centers, with barriers ensuring cleanliness. However, SC 4 scored lowest due to layout issues, including the qibla direction facing the entrance, disrupting

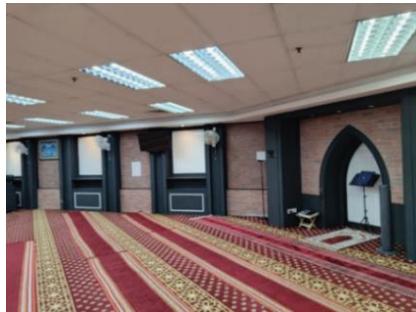
SC 4 received the lowest scores for odors, particularly from female respondents, highlighting the need for improved odor management. SC 3 excelled in group prayer space and modern finishes, featuring full carpeting that enhanced aesthetics and comfort (Figure 4). These findings highlight the

Figure 4: Prayer Area in SC 3

SC 3 enhances user comfort with full carpeting, creating a warm and welcoming prayer environment, unlike the tile flooring used in other centers. Lighting evaluations across all centers showed satisfactory performance, with adequate illumination meeting user needs effectively.

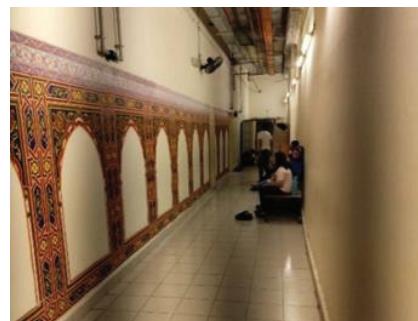
SC 5 excelled in prayer room placement, offering three conveniently located rooms on different floors. In contrast, SC 2's rooftop carpark location and SC 4's secluded walkway (Figure 6) received lower scores due to accessibility challenges, reflecting issues noted in [8].

Figure 6: Walkway Towards Male Prayer Room in SC 4

Pathway lighting was excellent in SC 1, SC 5, and SC 2, enhancing safety with well-lit pathways. However, SC 4 scored lowest due to dimly lit and isolated pathways, impacting user comfort and security. Adequate lighting is crucial for safe prayer room access.

to ensure user satisfaction. Clear, visible, and gender-specific signage is crucial for guiding visitors effectively, while well-marked and safe pathways reduce confusion and improve accessibility.
