FAILURE MODES OF GFRP AFTER MULTIPLE IMPACTS DETERMINED BY ACOUSTIC EMISSION AND DIGITAL IMAGE CORRELATION

ABSTRACT

KEYWORDS: GFRP; impact; CAI tests; digital image correlation; acoustic emission

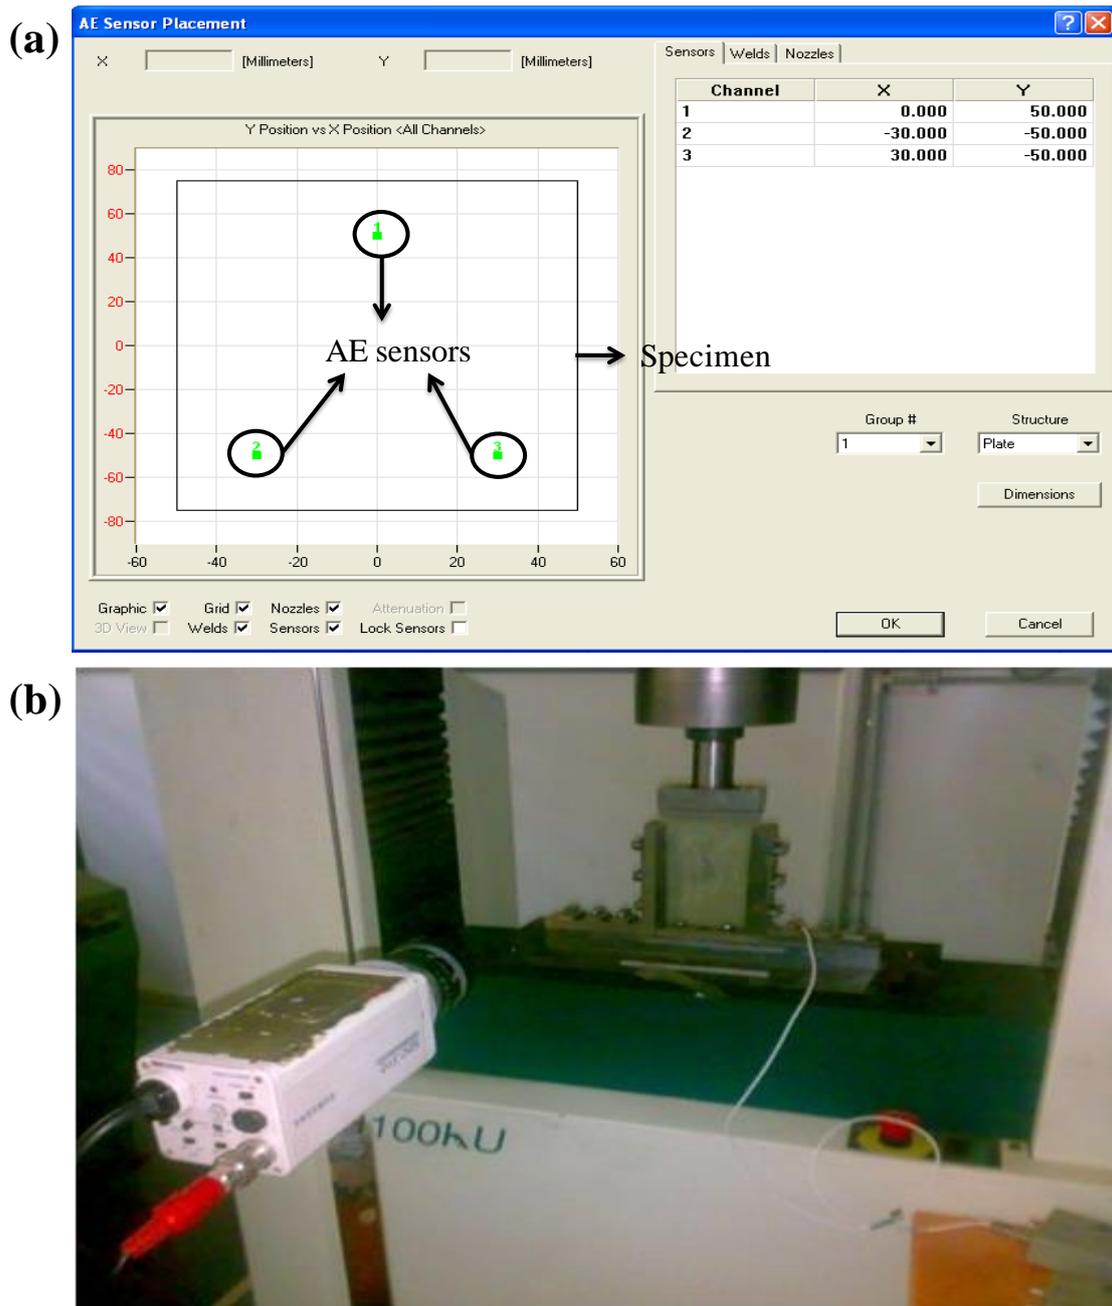
Figure 1. (a) AE sensor placement, (b) Specimen under static compression test

Digital image correlation allowed monitoring the full field displacement during CAI loading on the surface of the specimens visually without any hindrance. Figure 1(b) shows the CCD camera and placement of the specimen in the compression fixture. The range and size of the cracks have no effects whatsoever on DIC technique. Every care has been taken to ensure that the non-impacted side of the laminate appeared with uniform color, although obviously some white noise can be present as the consequence of geometrical differences due to mismatches in production. To account for this, for every laminate a threshold has been applied to gray level histograms of each image, as it appears at time 0 of loading to be able to measure the amount of damage produced

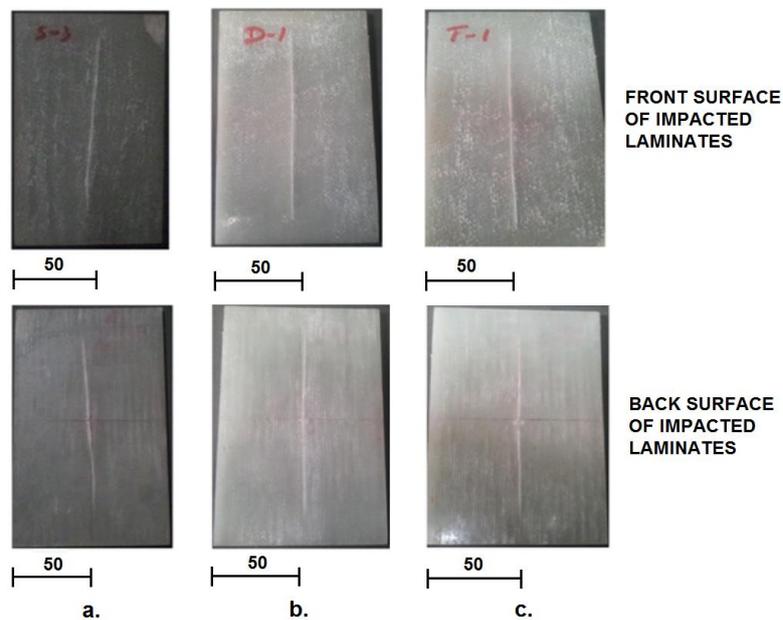
Figure 2. Crack pattern on both surfaces for: (a) Single impacted (b) Double impacted (c) Triple impacted laminates (scale in mm)

moves on is the fact that multiple impacts intensify the damage inside the laminate, causing very quick damage accumulation and promoting damage progression at a faster rate. Figure 2 shows a typical visualization of the laminates subjected to multiple impacts. Even though in all the cases the extent of damage was visible on both tension and compression side, as the number of impacts increases the extent of damage area also is growing, with particular evidence on the rear side. Moreover, the impactor trace is much more visible on the rear face for double and even more for triple impact, which suggests that a kind of forming process occurs during the impact event, which may involve the presence of different damage modes. On the other side, a kind of compensation effect may occur, in the sense that slight curvature caused by impact visible on both sides of the laminate may slightly stiffen the composite, when subjected to further impact events (Short et al., 2002) events (Short et al., 2002).

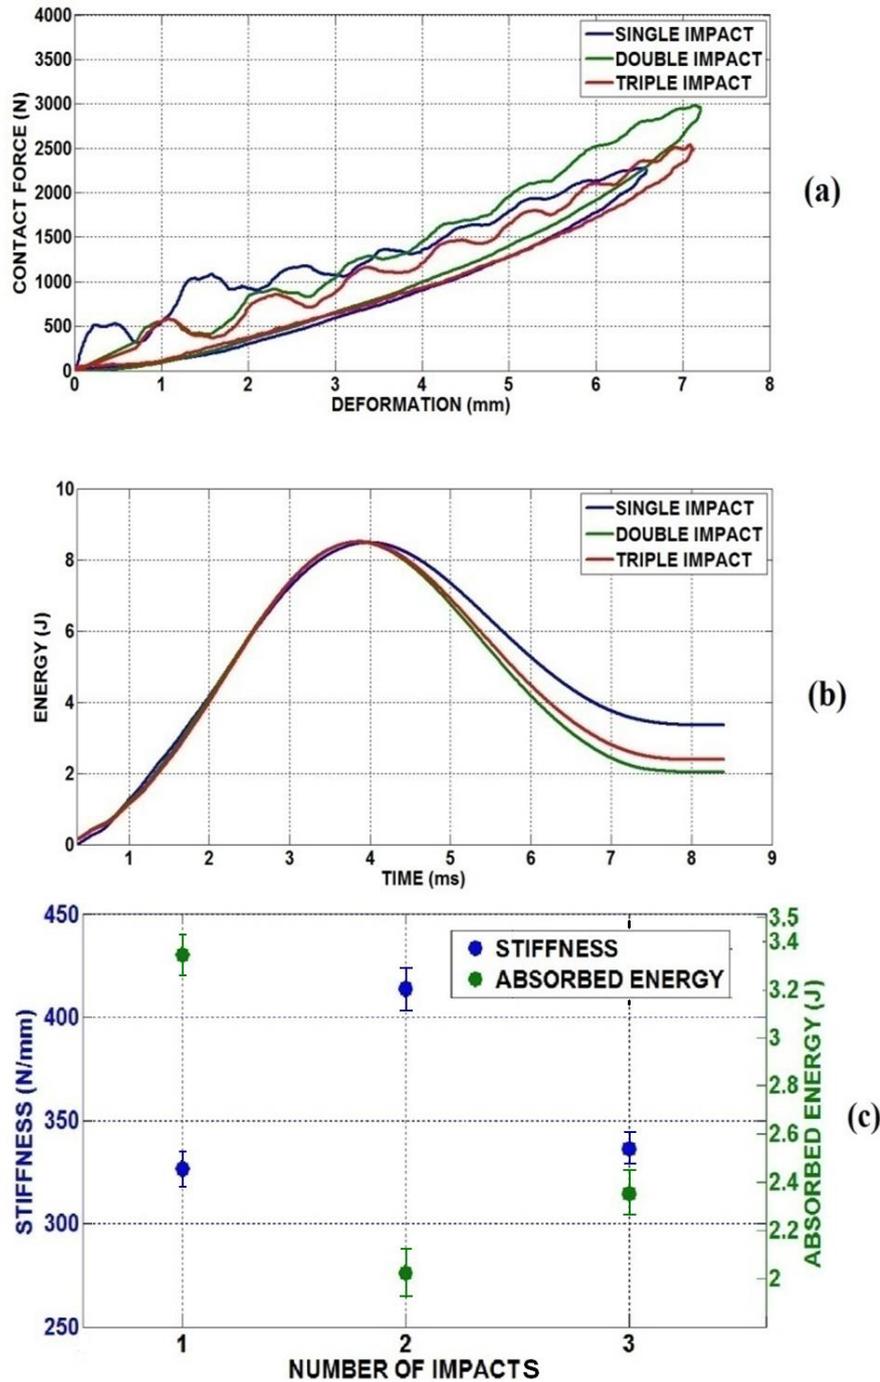
Figure 3. Response of Glass/Epoxy specimens subject to multiple impacts: (a) Contact force vs. deformation; (b) Energy vs. time; (c) Linear stiffness, Absorbed Energy vs. Number of Impacts

Figure 3(a) and 3(b) show the contact force vs. deformation and energy vs. time response of glass/epoxy laminates subjected to single, double and triple impacts, respectively. The stiffness and absorbed energy were recorded for each category of specimens. It was evident from the results that single impacted laminates retained the largest amount of damage in comparison with double impacted ones: this may be due also to matrix compaction making the impacted site harder on second impact, together with the previously observed effect of curvature (Wyrich & Adams 1988). During the third impact the absorbed energy was again higher, which was likely to be due to damage incurred on the fibers and inadequacy of degraded fiber/matrix interface to withstand damage. This was also quite evident from the linear stiffness values shown in Figure 3(c) for laminates subjected to multiple impacts: the significance of linear stiffness during falling weight impact tests, as an indication of stress relaxation, was discussed already by Santulli (2003). In general, after third impact, the rigidity of the laminate is substantially reduced: it was proposed that the extent of this reduction would

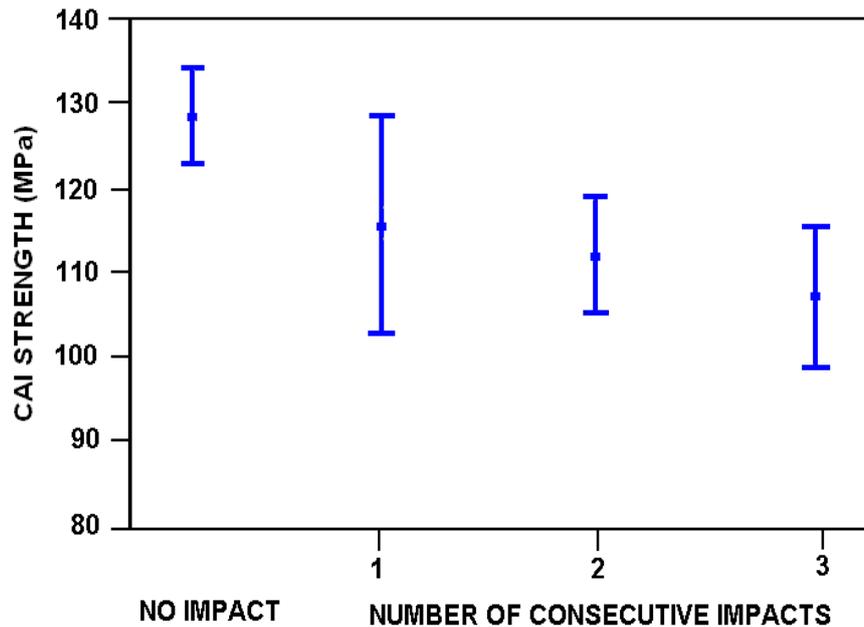
Figure 4. Compression strength data (average and standard deviation) for laminates impacted one, two or three times

In Figure 4 compression strength data for laminates impacted consecutively one; two or three times are reported, compared with the same data for non-impacted laminates. In general terms, the decrease of compression strength appears gradual for each further impact, possibly with more limited degradation between the second and the third impact. It can be therefore suggested, for comparison with what observed also in Figure 3, that the material becomes significantly less rigid in the occasion of the third impact, although it does not lose much strength because of its capability of accommodating further deformation in the form of damage. It is important at this point to try to explain this variation of properties in terms of extension of the damage area.

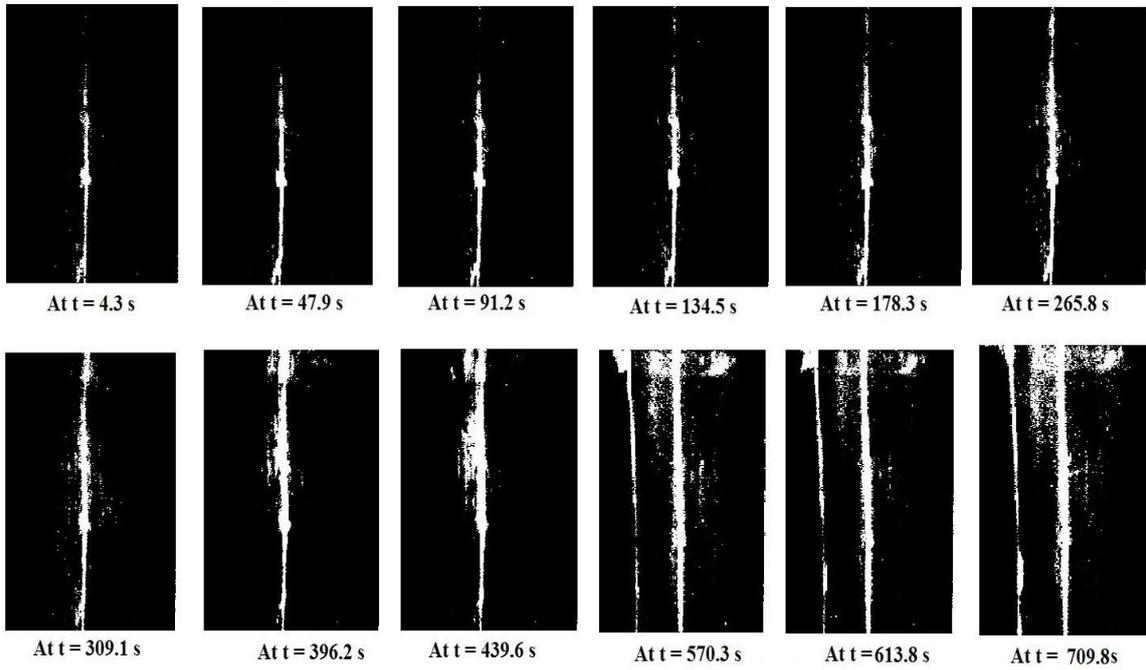
Figure 5. Damage progression of single impacted laminate subjected to CAI test

Figures 5 to 7 show the pictorial representation of the processed images of the snapshots captured at different stages of loading for single double and triple impacted specimens subjected to compression loading. A MATLAB code has been developed to separate both the white and black pixels based on the estimated threshold, which will be used further to estimate the damage area pertaining to each image during the different stages of loading. It is clearly visible from processed images that damage progresses from the impact point during compression loading, though in the final part of it also other fronts of propagation open up in other regions of the laminate. However, other differences are perceivable between laminates subjected to single, double and triple impact, in the sense that while the first ones presents a crack that is present only in a part of the surface until some load is reached. This in the case of the sample whose test is shown in Figure 5 is around 200 seconds during testing, corresponding to around 65 MPa. In contrast, in Figure 6 and 7 the sample is already cracked on the impact surface at the beginning of the CAI loading, as the results of two or three impact events, respectively. As from the typical graph depicted in Figure 8, the damage area is much larger for laminates

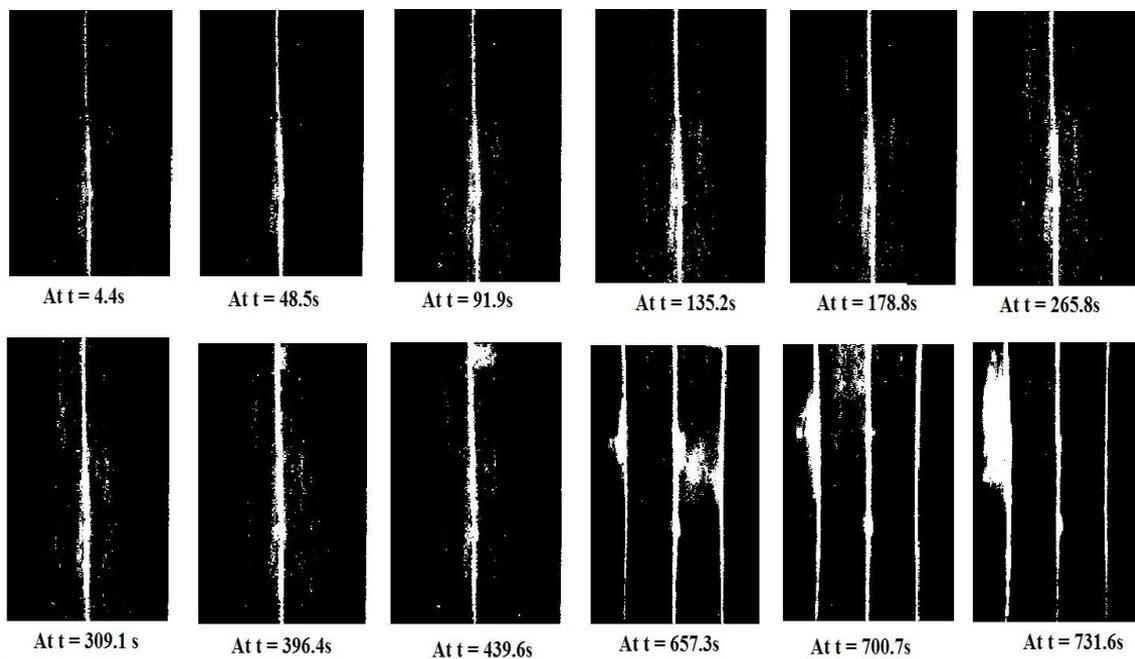
Figure 6. Damage progression of double impacted laminate subjected to CAI test

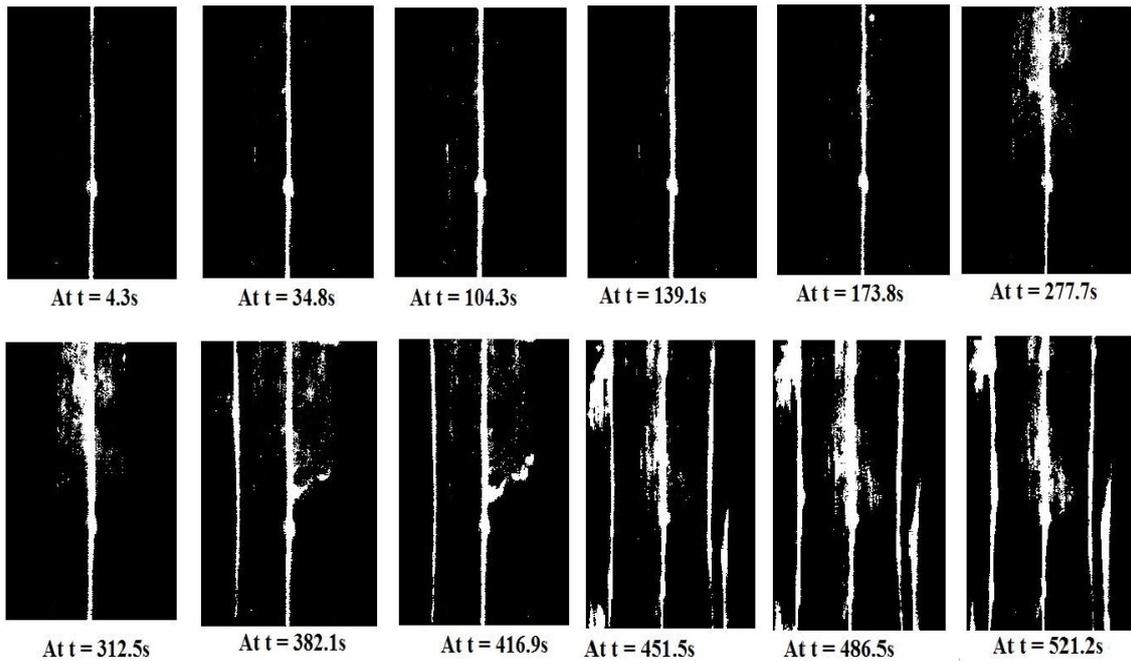
Figure 7. Damage progression of triple impacted laminate subjected to CAI test

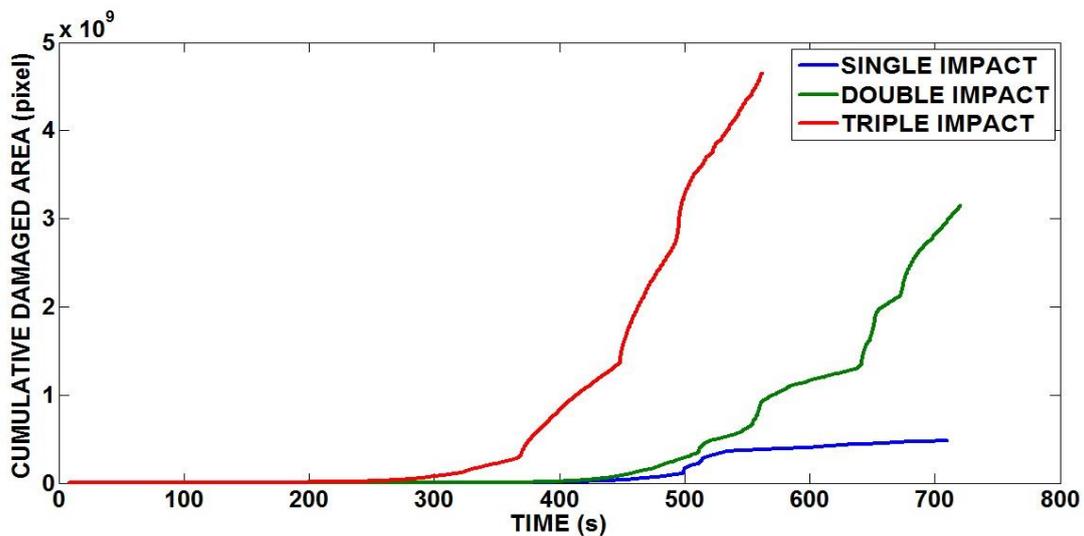
Figure 8. Comparison of cumulative damage area versus loading time response for single, double and triple impacted specimens subjected to CAI test

subjected to triple impact than for those subjected to single and double impact and it starts increasing much earlier during the loading time.

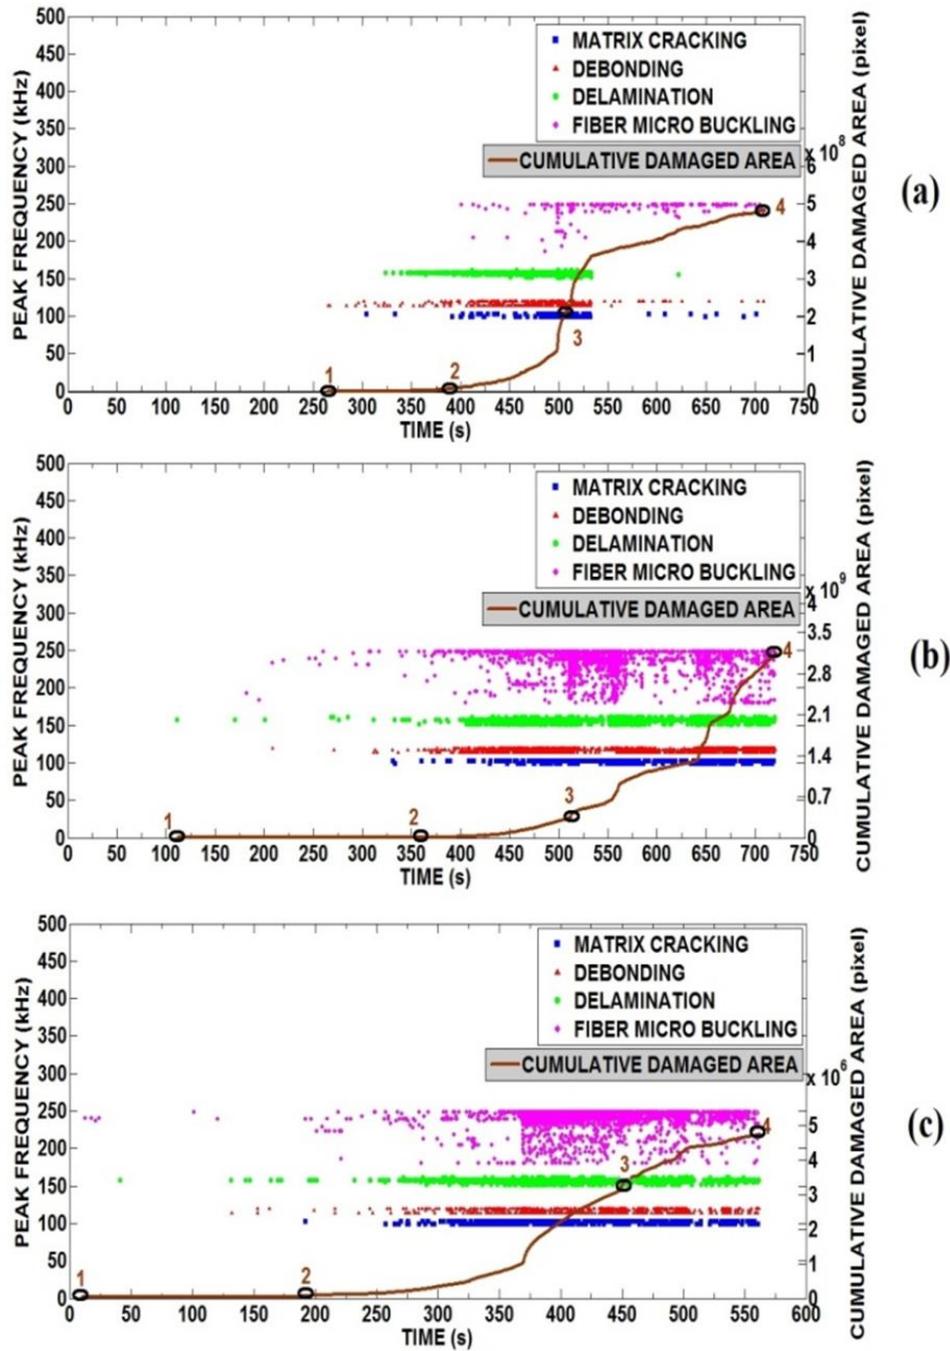
Figure 9. Peak frequency, Damaged area vs. Time for laminates subjected to:
 (a) single, (b) double and (c) triple impact

Acoustic emission can offer more information on damage modes occurring in the composite during CAI loading: Figure 9(a) to (c) show the peak frequency and cumulative damage area versus loading time for laminates subjected to single, double and triple impact events and then subjected to compression tests. Four distinct ranges of peak frequency content such as 90 - 110 kHz, 112 - 128 kHz, 136 - 180 kHz and 180 - 250 kHz were identified which are most likely related to the different failure modes, such as matrix cracking, debonding, delamination, and fiber micro buckling respectively. This was suggested on the basis of a series of studies carried out on AE

In Figure 9, as in Figure 11 to 15, four points during the compression loading have been marked as 1, 2, 3 and 4. The four consecutive points were respectively attributed:

- 1: damage initiation (first AE events detected)
- 2: damage propagation (DIC measures for the first time an increase of damaged area)
- 3: unstable damage growth (maximum CAI stress is reached)
- 4: laminate failure (rupture)

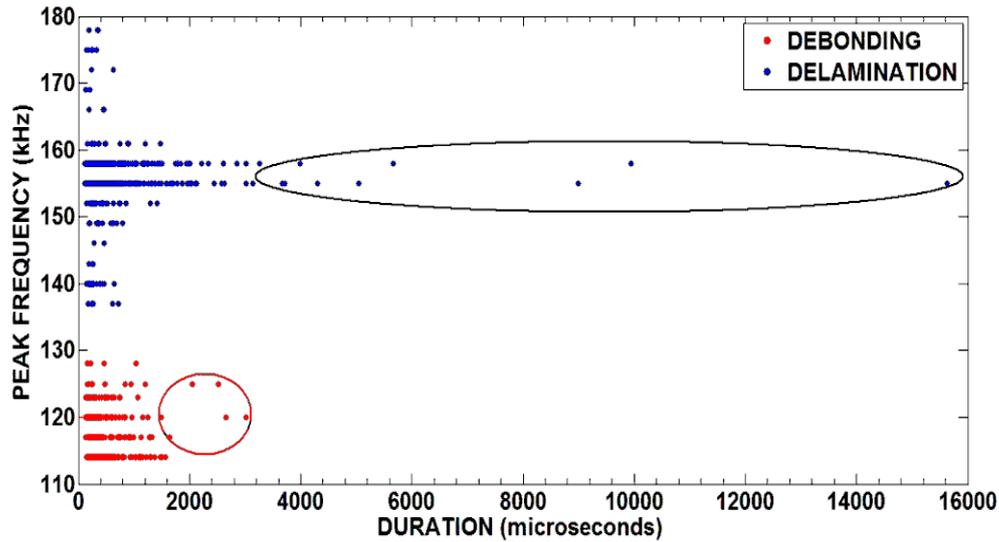
Figure 10. Peak frequency versus duration for AE hits between 112 and 180 kHz on laminates subjected to triple impact

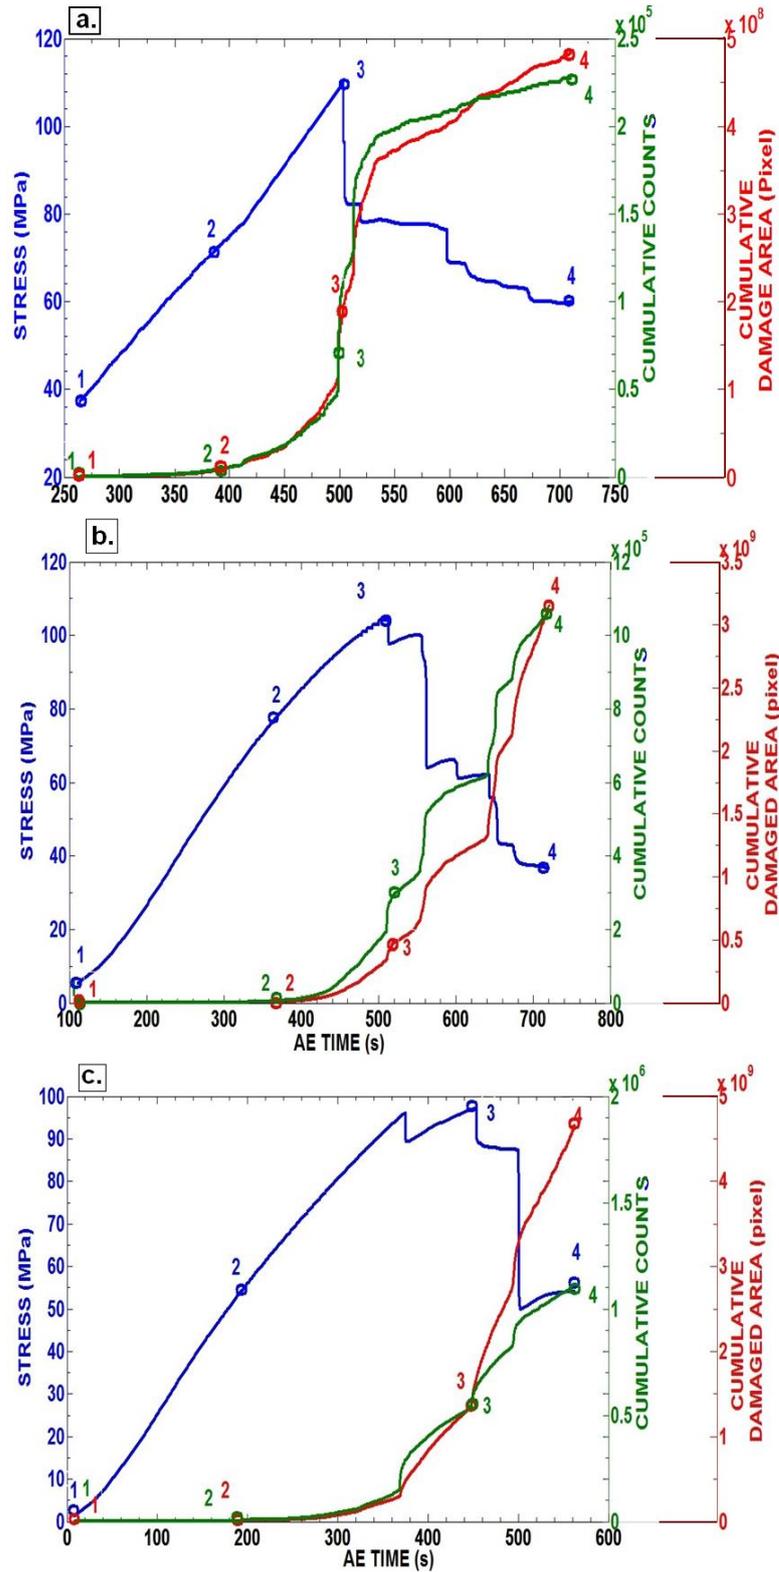
Figure 11. AE cumulative counts, cumulative damaged area, and stress versus time during CAI loading for laminates subjected to: (a) Single, (b) Double and (c) Triple impact

From Figure 11, AE cumulative counts were revealed higher for laminate subjected to triple impact, even during the initial stages of loading. It is important to note that AE activity was quite energetic also in periods during loading in which impact-damaged area did not substantially grow, in practice between point 1 and point 2. This occurs also in the case of laminate subjected to double impact, while in the case of laminate subjected to single impact, AE activity remains sparse and not significant up to point 2. To clarify what is the initial AE activity detected in the three cases (laminates subjected to single, double and triple impact events), in Figure 12, AE frequency spectra at point 1 are reported, from which fiber-related AE activity appears very considerable in the case of laminate subjected to triple impact. In Figures 13 to 15, AE frequency spectra at the points 2, 3 and 4 are reported: as loading stress increases, fiber micro-buckling events are increasingly prevalent, with greater evidence with laminates subjected to triple impact. It has been suggested elsewhere that such a prevalence of micro-buckling also on the laminate surface as far as load progresses, is due to the presence of localized delamination between the interior plies and the compressive stress creates an internal blister, gradually propagating to the edge of the plate (Berketis et al., 2008).

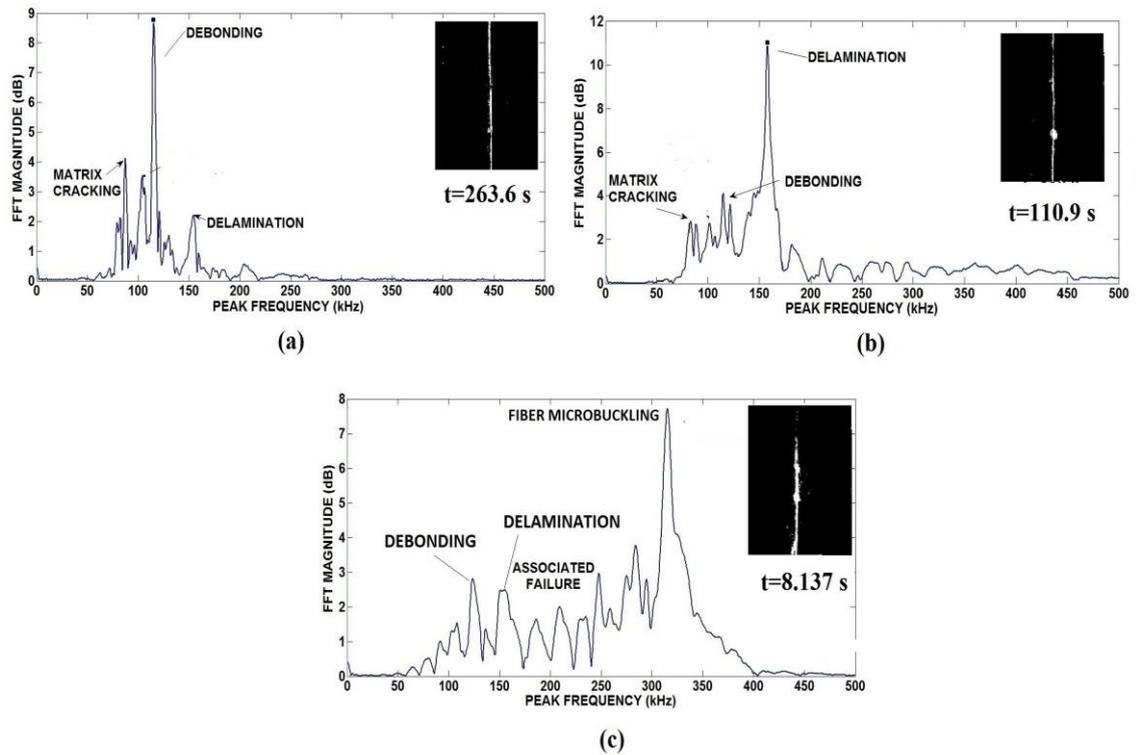
Figure 12. Frequency domain of AE signal at location 1 for (a) Single, (b) Double and (c) Triple impacted specimens subjected to CAI test

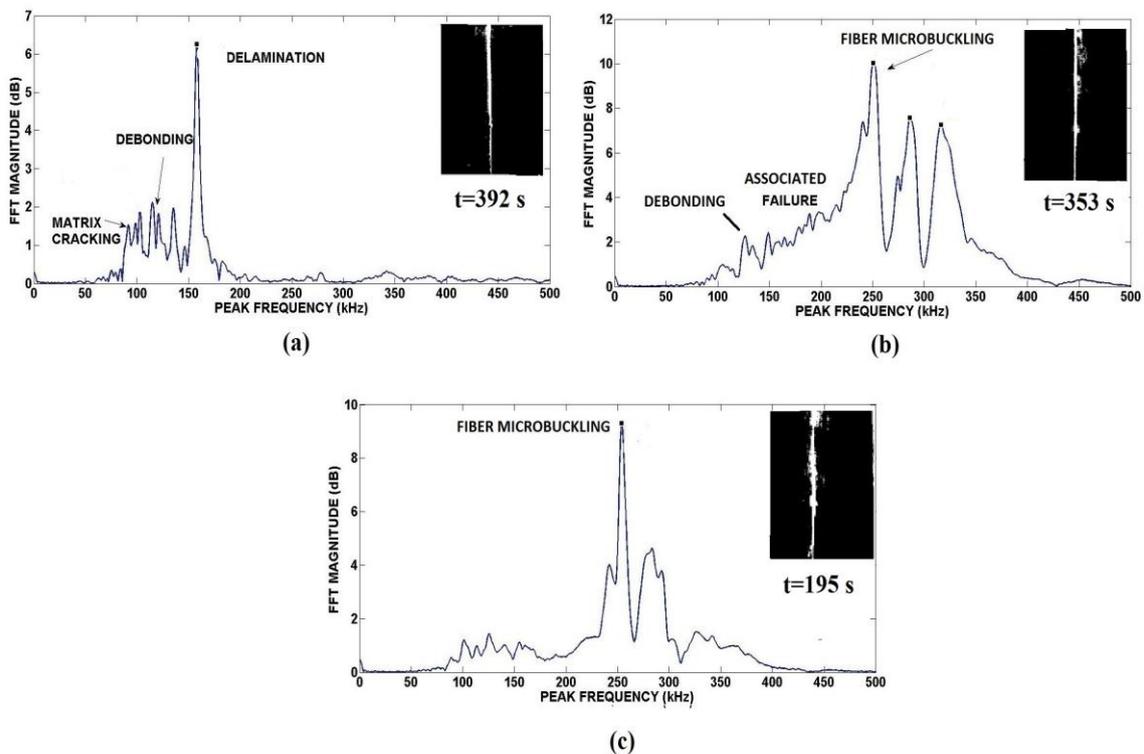
Figure 13. Frequency domain of AE signal at location 2 for (a) Single, (b) Double and (c) Triple impacted specimens subjected to CAI test

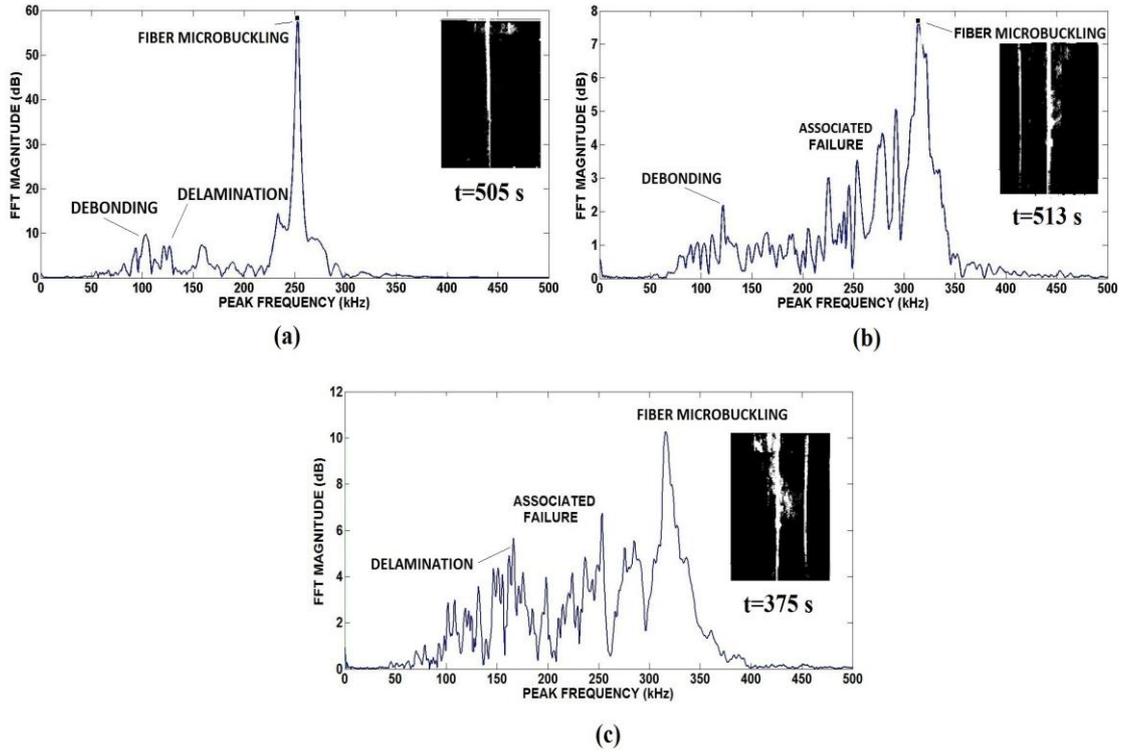
Figure 14. Frequency domain of AE signal at location 3 for (a) Single, (b) Double and (c) Triple impacted specimens subjected to CAI test

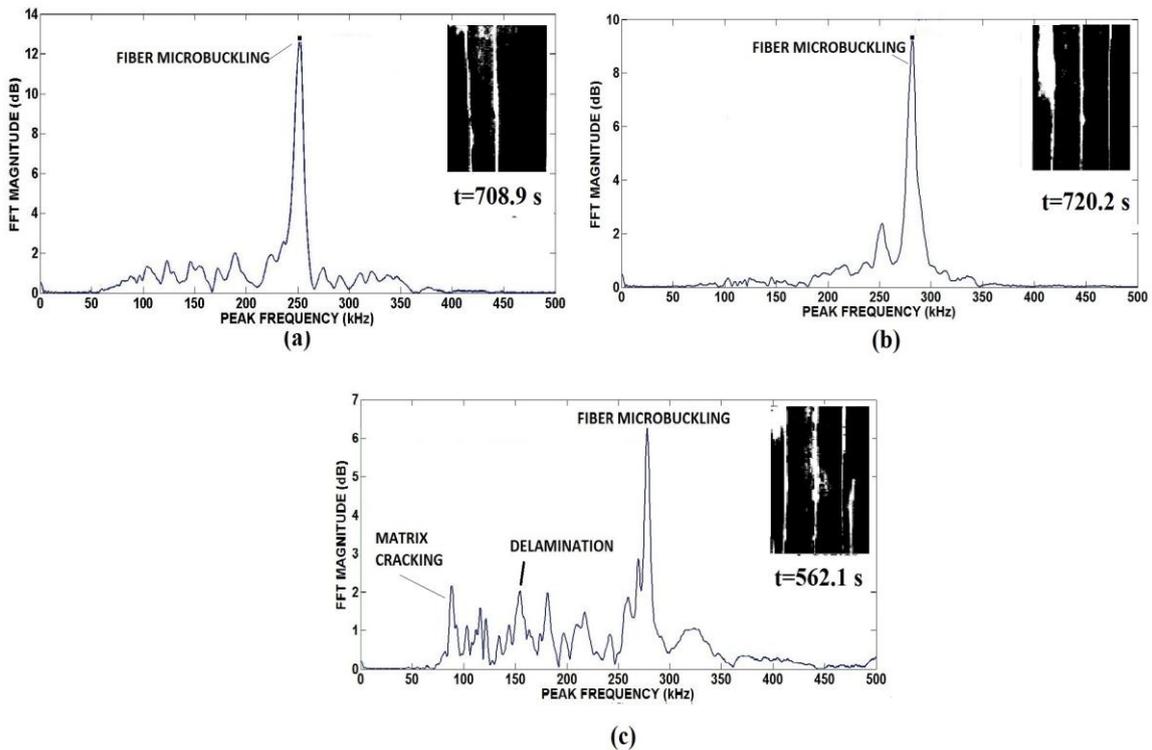
Figure 15. Frequency domain of AE signal at location 4 for (a) Single, (b) Double and (c) Triple impacted specimens subjected to CAI test
